Beware!

As a weatherer there is something that you need to be aware of that doesn't get mentioned very often, and that is the 'Bachmann tidemark.' Despite the name, the problem can be found in any manufacturer's range.

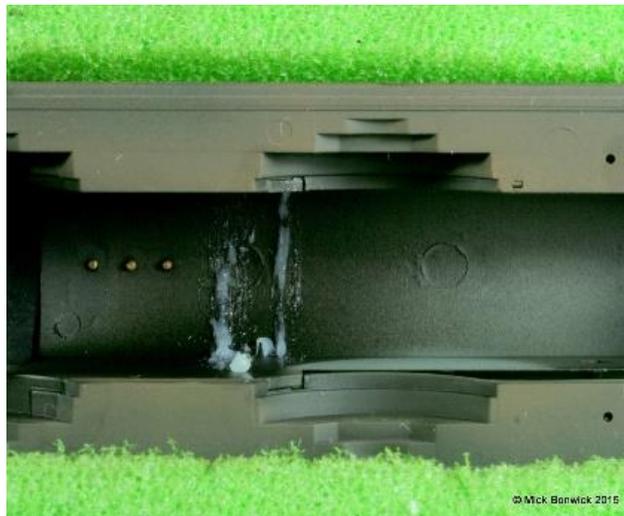
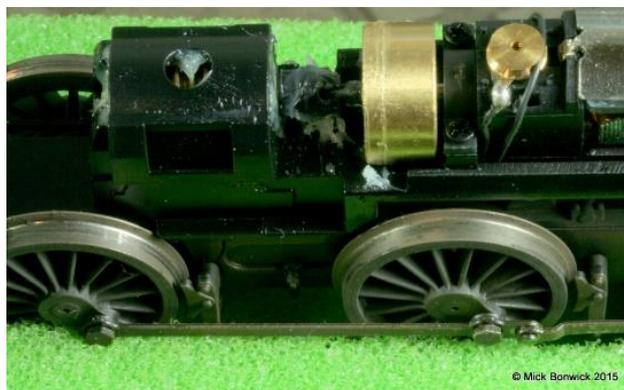
I know about all this because the first dozen or so locomotives that I weathered suffered from the same problem, hence the availability of illustrations!

Prevention consists of a thorough clean of the geartrain before any weathering is attempted. All grease and oil should be removed from the whole chassis and this will prevent the initial spreading over the body interior. When you've got the whole model in pieces it is a good plan to clean the whole of the body interior as well.
